# **General Aviation Airworthiness Alerts**

**AC No. 43-16**

**ALERT NO. 226  
MAY 1997**

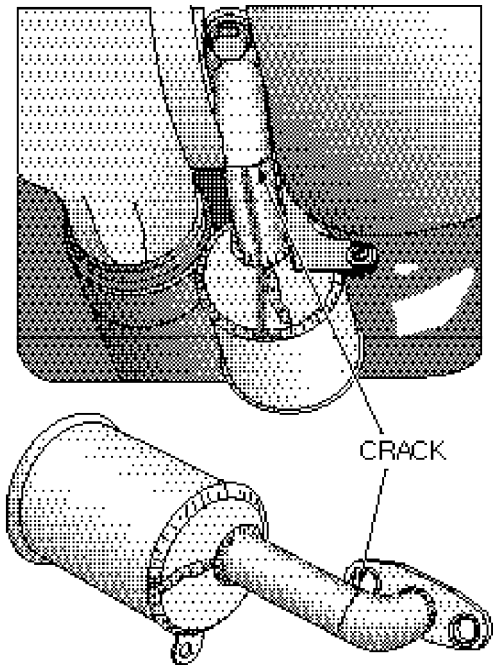
Troubleshooting this problem disclosed the cause was a large crack in the turbocharger oil return line. This line runs from the turbocharger to the reservoir located under the engine. The crack traveled around approximately 300 degrees of the line's circumference. The crack was located where it made a 90-degree bend, just below the mounting flange. (Refer to the following illustration.) The submitter speculated this defect was caused by metal fatigue due to vibration. When the crack location on the defective line was examined, the line wall thickness was much thinner on the outside of the 90-degree radius, where the crack had occurred. The submitter stated that this part is supplied by the aircraft manufacturer and not the engine manufacturer.

Part total time-1,738 hours.

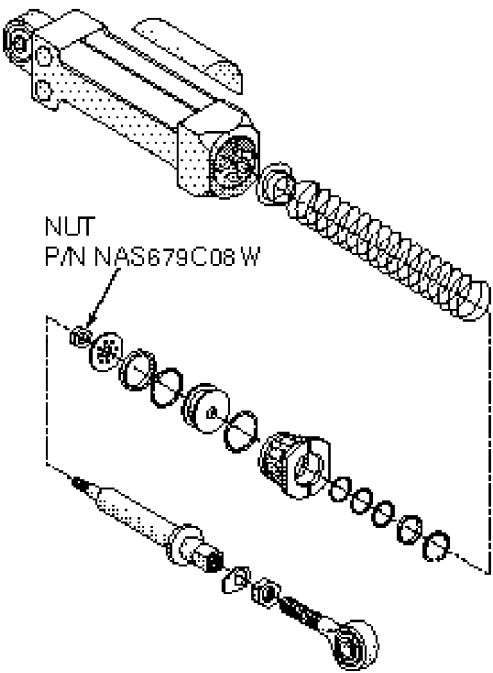
An initial inspection revealed hydraulic fluid was dripping from the entire length of the lower fuselage. Further inspection disclosed the hydraulic reservoir was empty. The source of the leak was traced to the pilot’s right brake master cylinder (P/N 45AS38401-012). The master cylinder piston rod had become disconnected from the cylinder barrel assembly. While disassembling the master cylinder, it was discovered that the piston retaining nut (P/N NAS679C08W) loosened and came off of the piston rod. (Refer to the following illustration.) This allowed the piston rod to protrude past the cylinder barrel and gland seals. The hydraulic system fluid had been depleted. The defective master cylinder was sent to the manufacturer for evaluation. Since the failure occurred internally, the

submitter recommended the manufacturer provide some guidance concerning inspection of inservice master cylinders for loose piston retaining nuts.

Part total time-2,545 hours.

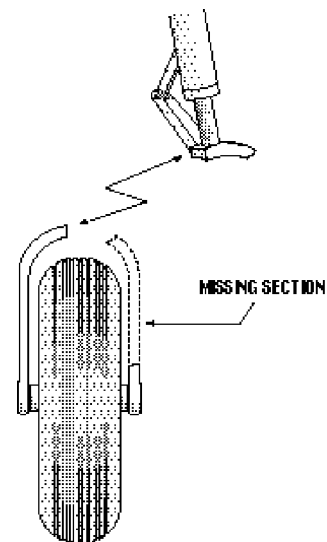
**Nose Landing Gear  
Structural Failure  
3220**

The pilot reported the nose landing gear failed during landing.

An inspection revealed the nose gear fork had broken where it attached to the piston assembly (P/N 1243009-201). Also, a section of the nose gear fork was missing. (Refer to the following illustration.) The submitter speculated this failure was caused by a "hard landing." It is possible that during the landing, the nose landing gear contacted the runway before the main gear. The only cure for this defect is education!

Part total time not reported.

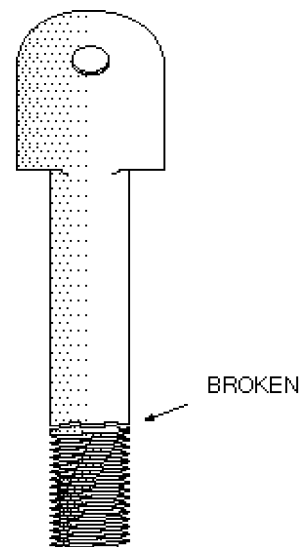
**Cessna  
Model 402B  
Businessliner****Nose Landing Gear  
Failure  
3220**

During a landing approach, the nose landing gear indicated "unsafe" when the pilot selected the "down" position. A ground observer informed the pilot the nose gear was trailing at approximately a 45-degree angle. A landing was made with the nose gear in the "up" position.

An inspection disclosed that the nose gear fork bolt (P/N 5045211-2) had broken. (Refer to the following illustration.) The submitter also found the bellcrank (P/N 0842104-3) was broken. The submitter speculated this defect resulted from failure of the fork bolt. Also, this defect may have been caused by metal fatigue, high time, and the age of the fork bolt.

Part total time-9,243 hours.

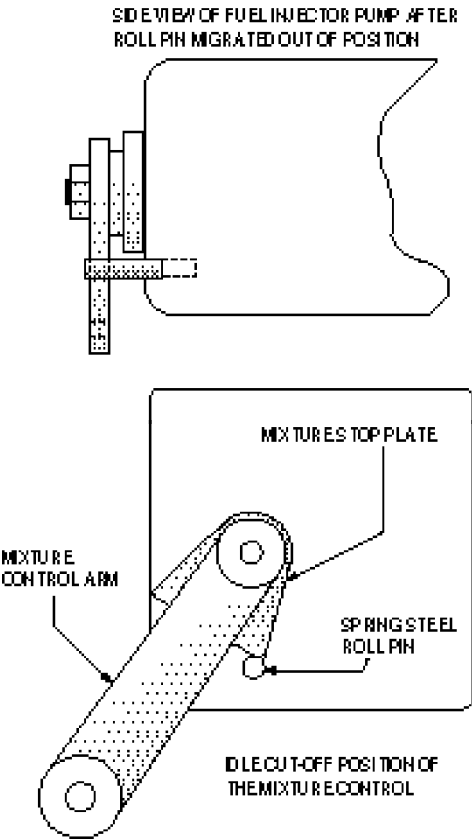
The pilot reported that during a local flight, at an altitude of 4,500 feet, the fuel mixture control was leaned until engine roughness was detected. An attempt was made to move the mixture control to enrich the mixture, but the control failed to move. The mixture control could not be moved from the "idle cutoff" position. A safe off-airport landing was made with no personal injuries or damage to the aircraft.

This system may also be used on other make and models of aircraft. The submitter contacted several other repair facilities and found it may be common practice (although not an authorized practice) to use "epoxy" filler in holes which have become elongated. It was properly stated that if the steel roll pin wears away the aluminum housing, it will surely do the same on the "epoxy" filler. This report has been sent to the responsible FAA aircraft certification office for appropriate action.

Part total time-1,500 hours.

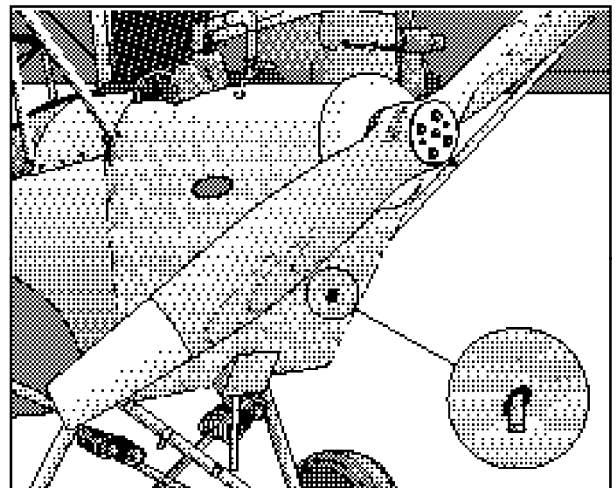
An investigation revealed that an engine oil system drain extension, installed by the original builder, had broken allowing all of the oil to escape. (Refer to the following illustration.) The oil drain extension had been fabricated from copper tubing, and it was intended to facilitate draining the engine oil without removing of the lower engine cowl. The oil drain extension was broken adjacent to the adapter on the bottom of the oil sump. This extension was not a part of the original aircraft plans, and the extension had been devised by the builder. Buyers of amateur aircraft should inspect them closely for adherence to the plans or the kit manufacturer's data.

Part total time-120 hours.
